Manhole Inspection Summary

Manhole # S35AA1023MH

Location Address: **3500 CALVERT ST**

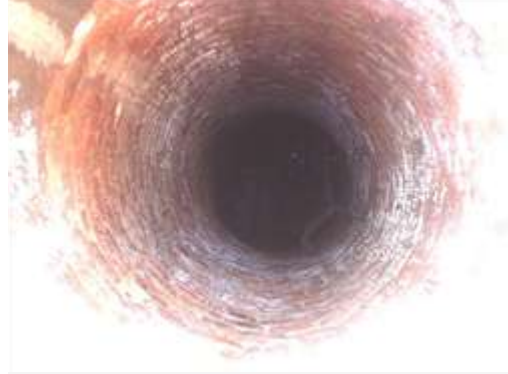
Top View

Corroded and missing steps. Bench debris.

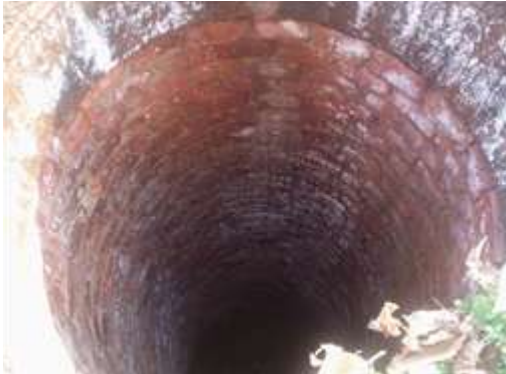
Defect

Adjustment deterioration and infiltration.

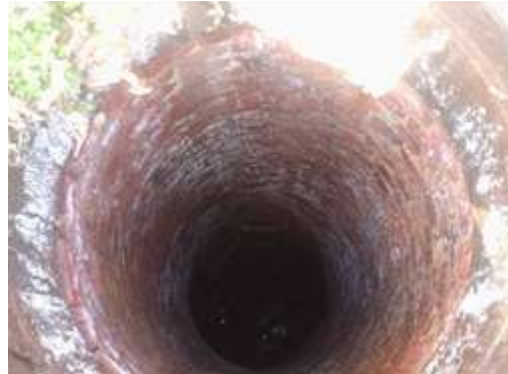
Defect

Frame leaks. Adjustment deterioration and infiltration. Barrel infiltration.

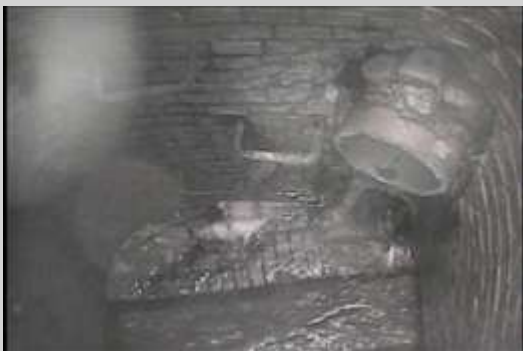
10 in. Circular Gravity Sewer Pipe In @ 5 O'Clock

Barrel deterioration and infiltration.

Infiltration: **Evidence** Pipe Seal Cond: **Broken**

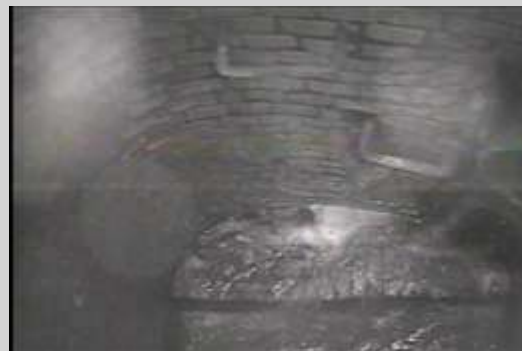
Drop In @ 5 O'Clock

Drop: **Outside** Rod and Bar
Angled: **Yes** Reading: **21.55** (ft.)
Inv Depth: **22.55** (ft.)

Drop Condition: **Open**

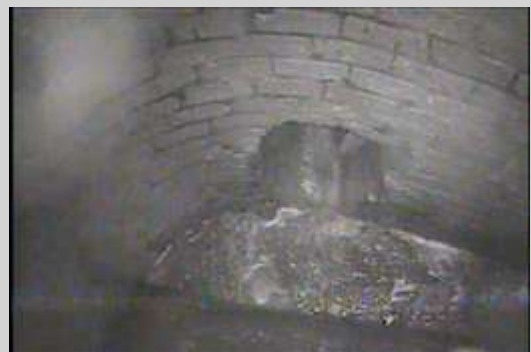
Drop In @ 9 O'Clock

Drop: **Outside** Rod and Bar

Drop Condition: **Open**
